# **Mobile Pentium® II Processor Specification Update**

Release Date: March 1999

Order Number: 243887-008

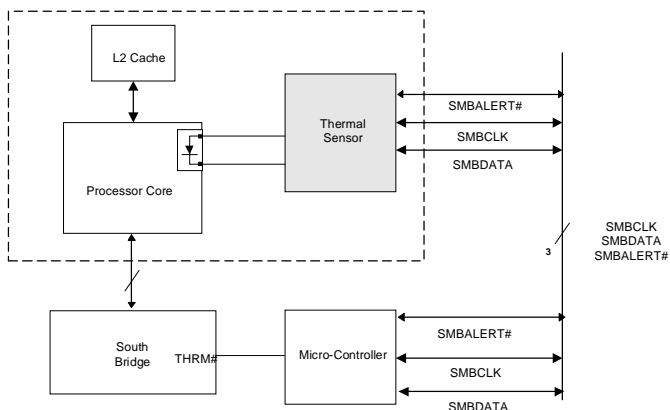
**Figure 1. An Example of Microcontroller Driven Thermal Management**

## **B30. Thermal Sensor May Assert SMBALERT# Incorrectly**

**PROBLEM:** The Mobile Pentium II processor and the Pentium II Processor Mobile Module have a thermal sensor that monitors the processor core's temperature. Please note that desktop systems could have a similar thermal device. The thermal sensor asserts SMBALERT# if the processor temperature exceeds the temperature limits set in the Alarm Threshold Registers (T<sub>HIGH</sub>, T<sub>LOW</sub>). It also sets the corresponding Status Register bits to identify the cause of the interrupt. Figure 1 gives one example of the how the SMBALERT# signal could be used in a system.

Under the conditions described below, the thermal sensor incorrectly generates the SMBALERT# interrupt. *All* of the following conditions must be met to trigger a false interrupt:
